NIOSH
Fire Fighter Fatality Investigation
and Prevention Program

Motor-Vehicle Incident Claims the Life of a Volunteer Fire Fighter and Injures a Volunteer Chief - Virginia

Fatality Assessment and Control Evaluation Investigative Report #F2000-01

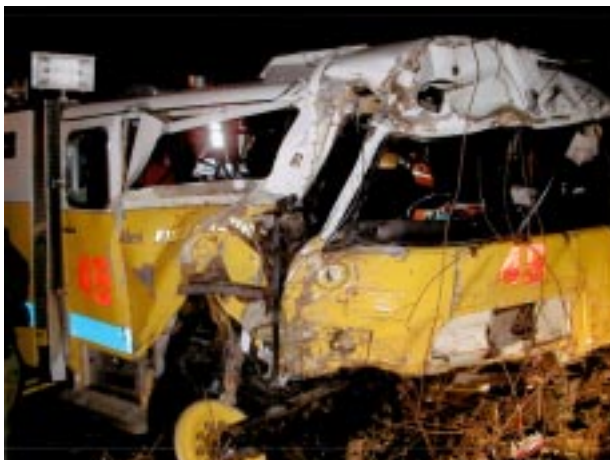
Rescue Truck Involved in This Incident

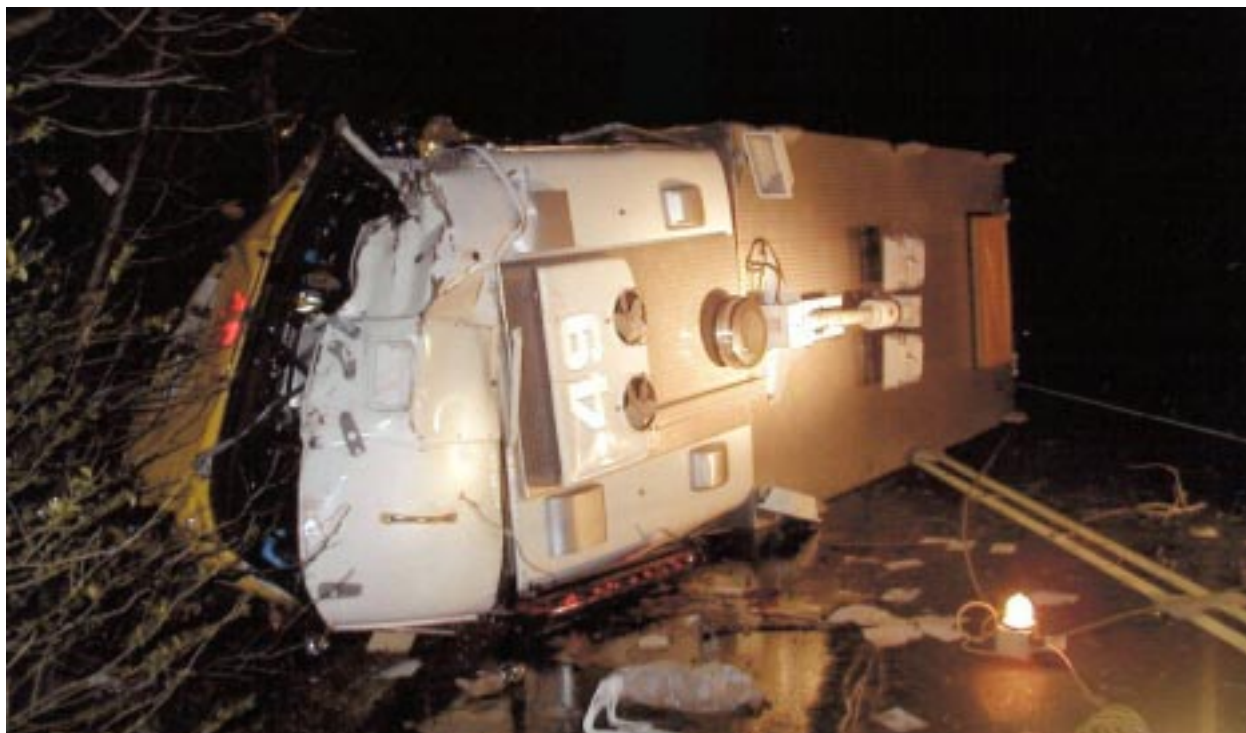
On December 18, 1999, a 22-year-old male volunteer fire fighter (the victim) died and a 30-year-old volunteer District Chief was injured after the rescue truck he was driving veered off the road, struck an oncoming car and then a tree. The incident occurred while they were responding to a reported gas leak at a private residence. The volunteer District Chief (driver) and a fire fighter (the victim) responded in Rescue 49. While en route, the driver looked down at the dashboard to lower his response priority by shutting off his lights and siren. While doing so, the truck's right side tires dropped off the road surface into a ditch. During the driver's efforts to bring the truck back onto the roadway, he overcompensated, causing the truck to cross the oncoming lane of traffic and strike an oncoming car. Just prior to striking the car, the driver started steering the truck back to the right to avoid a second collision. Due to the momentum of the truck, it struck a tree and flipped onto the driver's side (see Photo 1). Seconds after the wreck, the driver crawled out of his loose seat belt and out of the truck. Several

Photo 1. Rescue 1 After Impact With the Tree.

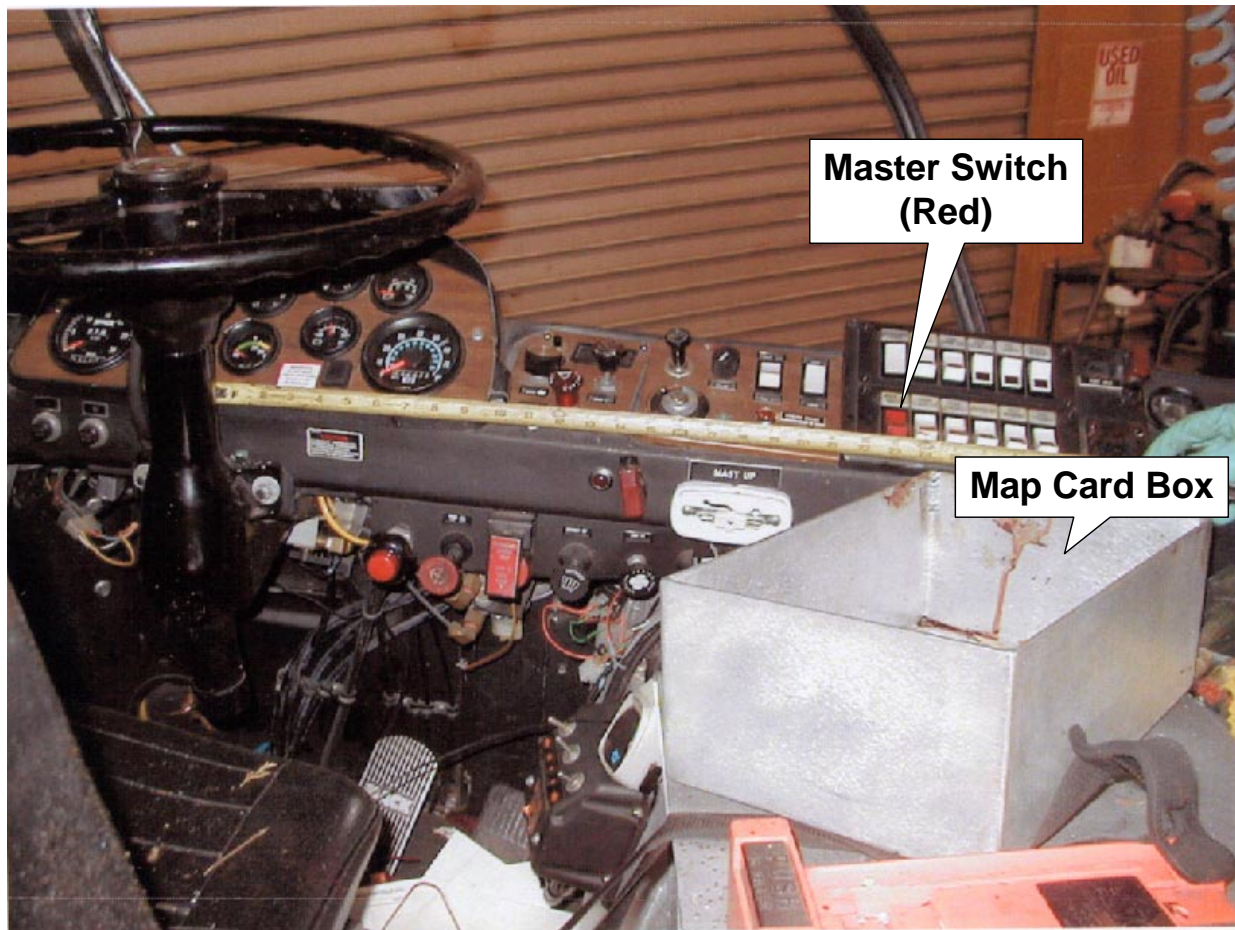
All units, except Rescue 49, were on the scene. The driver noticed there was very little radio traffic. To reduce his priority, the driver looked down at the dashboard and reached over to cut the lights off, via the master switch. *Note: The master switch, located on the dashboard between the driver's and officer's seat, is 23 inches from the center of the steering column. The driver had to reach up and over a metal 8-inch by 12-inch map card box (see Photo 2).* As the driver looked down at the dashboard area to find the master switch, he reached over to the right, with his left hand still on the steering wheel. *Note: The driver's arm length was insufficient to reach the controls without leaning while in the seated position. It is undetermined whether the driver inadvertently pulled the steering wheel to the right while he was reaching for the master switch or if the rescue truck followed a straight path instead of following the slight curve of the road.* The rescue truck's right front and rear dual tires dropped off the road surface, into a ditch and concrete culvert pipe (see Photo 4). The rescue truck traveled across an asphalt driveway and back into the ditch. The driver put both hands on the steering wheel and let off the accelerator. The police department analyzed the arc of the tire marks, determining a radius and the critical speed scuffs. They determined that the rescue truck lost control after leaving the driveway (see Photo 4). After the vehicle lost control it was determined that it was traveling approximately 51 mph at the time it came out of the ditch line and back onto the roadway. The driver tried to bring the truck back onto the roadway, however, he overcompensated, crossed into the oncoming lane of traffic, and struck a vehicle heading eastbound (Vehicle #1). Before impact with the oncoming vehicle (Vehicle #1), the driver steered the rescue truck to the right, attempting to avoid a second collision (Vehicle #2). It is estimated that the rescue truck was traveling approximately 45 mph

Discussion: When departments add additional equipment to an apparatus, they should consider if it will obstruct any controls the driver must operate. The department installed a metal 8-inch by 12-inch map card box in the center console of the rescue truck (see Photo 2). The driver had trouble reaching up and over the box to operate the master switch.

Photo 2. The Map Card Box and the Master Light Switch Inside the Cab.

Recommendation #1: Fire departments should take into consideration the movement required by the driver to reach switches and electronic

devices when developing apparatus specifications.¹

Discussion: The cab design is a very important factor for the safe operation of a fire apparatus. Controls which the driver must use with a blind reach should be placed directly in front of the driver, or above, at shoulder level. The driver of the rescue truck had to momentarily take his eyes off the road while he looked down at the dashboard to turn off the master switch. The driver's arm length was insufficient to reach the controls from the seated position, causing him to reach to the right. If existing controls are too cumbersome for drivers to operate without taking their eyes off the road or having to overextend their reach, a passenger riding in the officer's seat should operate the controls. Additionally, consideration could be given to using a different shape or texture for the main switch (e.g., the main switch is round and all others are square shaped) when a blind reach is necessary. This would provide drivers with an alternative means to find the correct switch without having to take their eyes off the road.

Recommendation #3: Fire departments should ensure that the placement of additional equipment (e.g. radios and map card boxes) added to an apparatus does not interfere with the driver’s ability to operate controls.¹

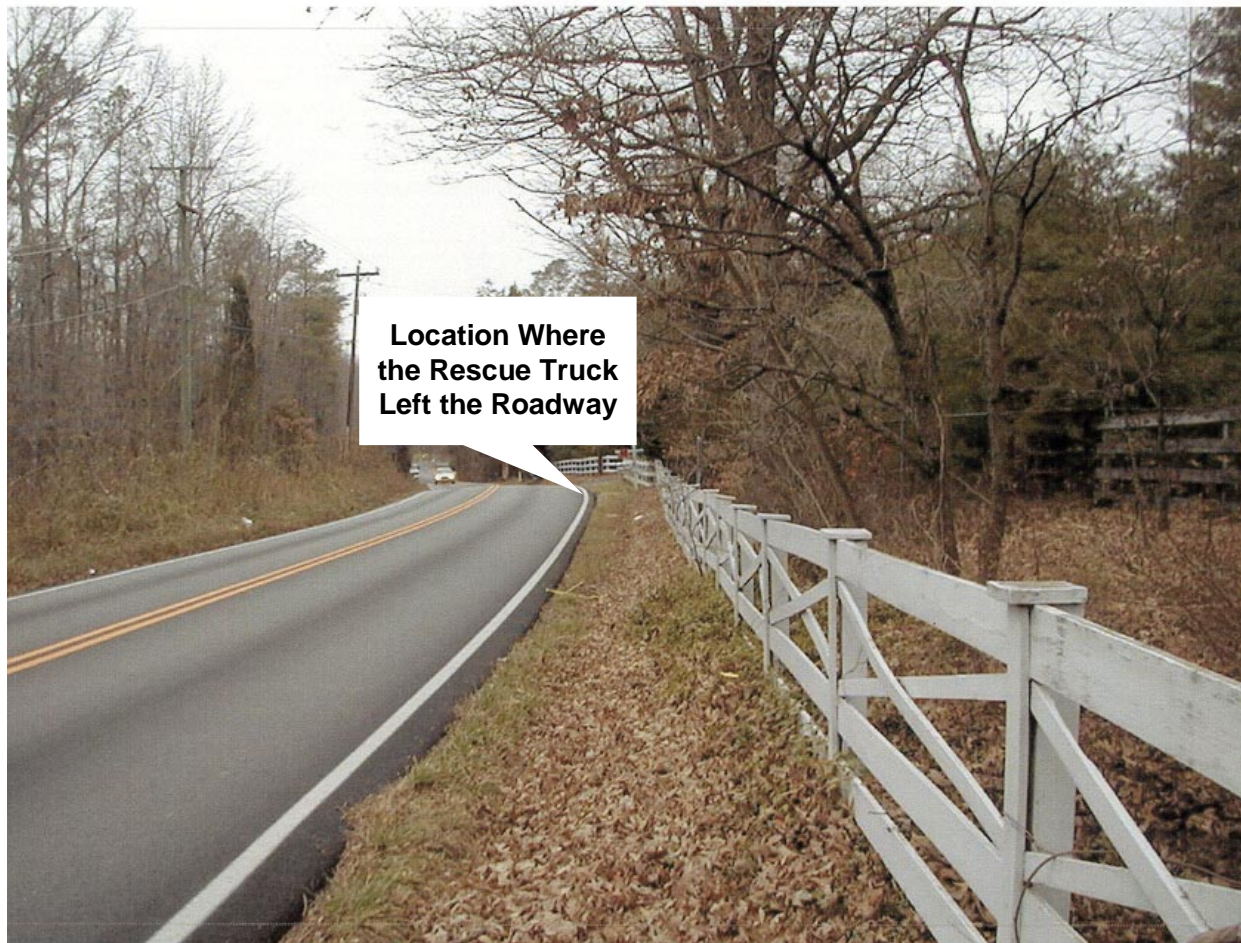
Photo 3. Incident Site.

The rescue truck was traveling on a two-lane residential road in the westbound direction; the lane measured 9 feet 9 inches wide. The eastbound lane measured 9 feet 8 inches wide. The pavement markings consisted of solid double-center yellow lines and white fog lines. The road was asphalt and at the time of the incident was in good condition. It had no drivable shoulder and dropped into a moderate ditch (see Photos 3 and 4). The posted speed limit was 35 mph with an advisory safe speed of 30 mph due to an approaching curve. This road had been identified by the fire department as a dangerous road due to the

insufficient shoulder. Within the past year, there have been four fatalities on this road near the incident site.

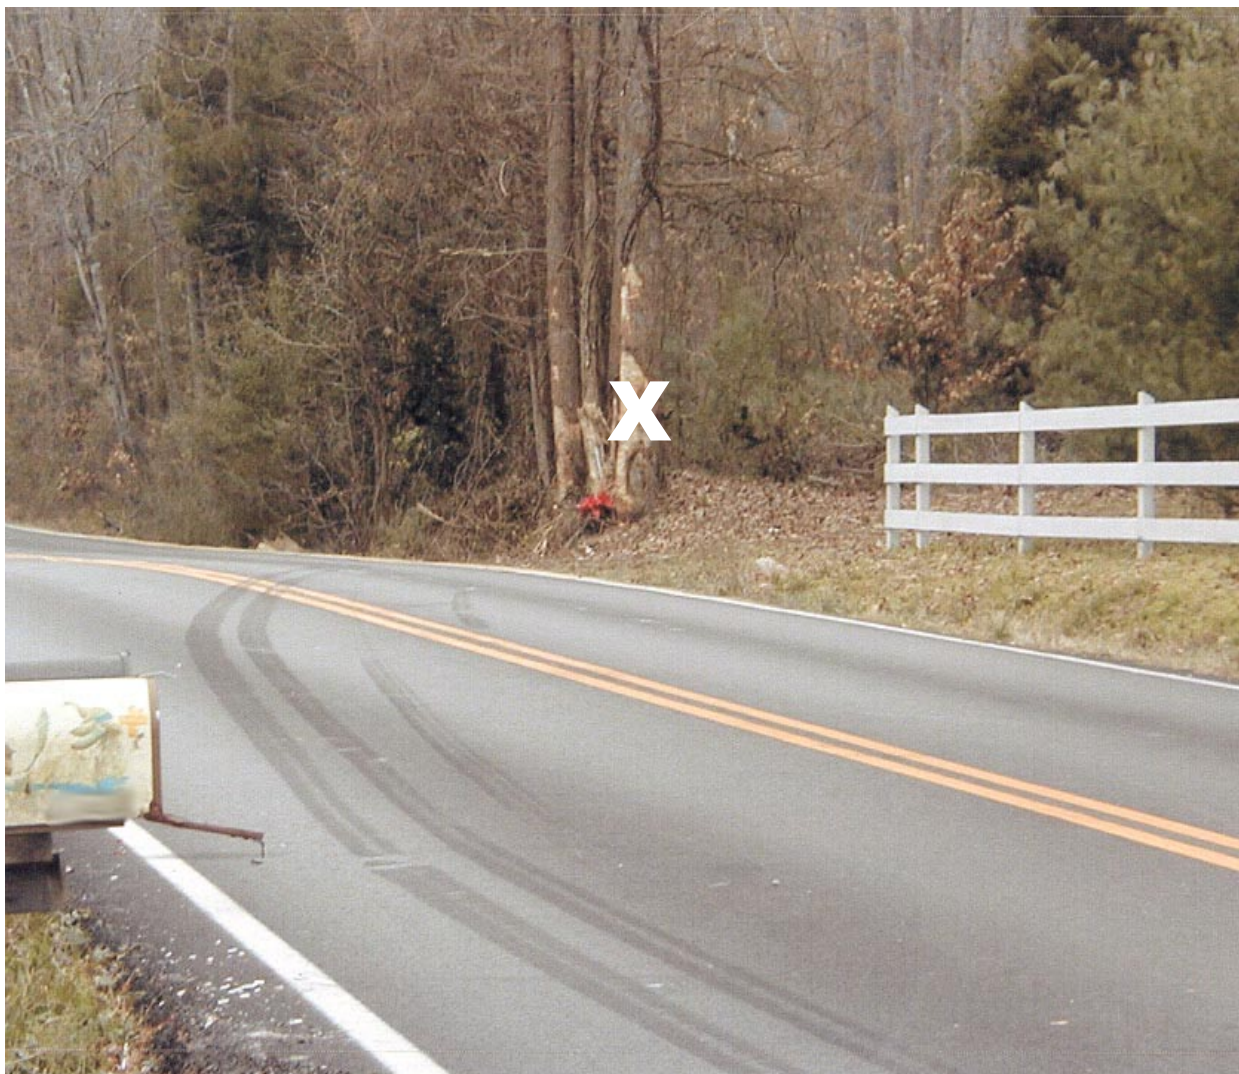
at this point. After impact with Vehicle #1, the truck crossed back into the westbound lane, went off the road surface and hit a large tree (see Photo 5). *Note: The police department determined that the truck's weight shifted to the driver's side as the truck struck the tree. This weight shift caused the truck to overturn onto the driver's side. The speedometer of the rescue truck was analyzed and it was determined that the rescue truck was traveling approximately 55 mph at the time of impact with the tree.* Vehicle #2, traveling eastbound behind Vehicle #1, ran off the road to avoid hitting the rescue truck. Both Vehicles #1 and #2 ran off the road and into the eastbound ditch; however, none of the occupants were injured. Several residents who heard and saw the collision of the rescue truck, called 911 to report the motor-vehicle incident. Immediately after the collision, the driver crawled out of his loose seat belt and out of the cab through the shattered windshield. The victim was suspended by his seat belt, and was hanging over the center console. Between 1944 and 1951 hours, the following units were dispatched to the motor-vehicle incident involving the rescue truck: Engine 43, Engine 44, Engine 53, Engine 54, Engine 93, Truck 97, Ambulance 422, Ambulance 731, Ambulance 736, BC 1, BC 2 and BC 4. An off duty fire fighter/paramedic was several cars behind the wreck in a privately owned vehicle when he approached Rescue 49 and saw it overturned on its side. The fire fighter/paramedic ran to Rescue 49 and saw the driver by the front of the truck. He asked the driver who else was on the apparatus and the driver replied that the victim was inside the vehicle. The fire fighter/paramedic climbed on the passenger side of the truck and saw a civilian holding the victim's head. The fire fighter/paramedic did a quick assessment of the victim and noticed that he had a very weak pulse and agonal respiration. He noticed the victim had extensive head trauma and his legs were pinned

Photo 5. The X Indicates the Point of Impact of the Rescue Truck With the Tree.
